Gooniyandi River Monitoring Report: 2009 – 2010

Marcus Finn, Pippa Featherston and the Bayulu-Gooniyandi Rangers

Marcus Finn, Pippa Featherston and the Bayulu-Gooniyandi Rangers. *Gooniyandi River Monitoring Report: 2009 – 2010* CSIRO Ecosystem Sciences, Darwin NT.

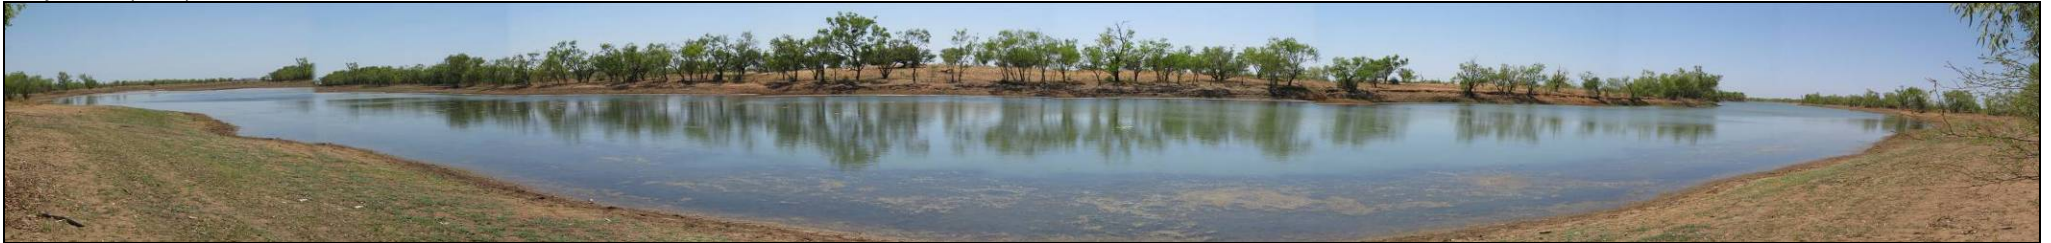
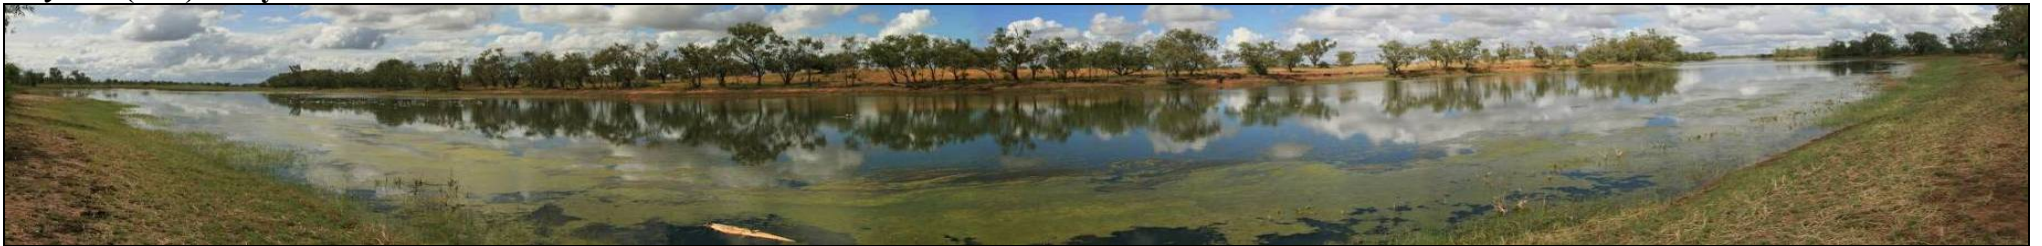
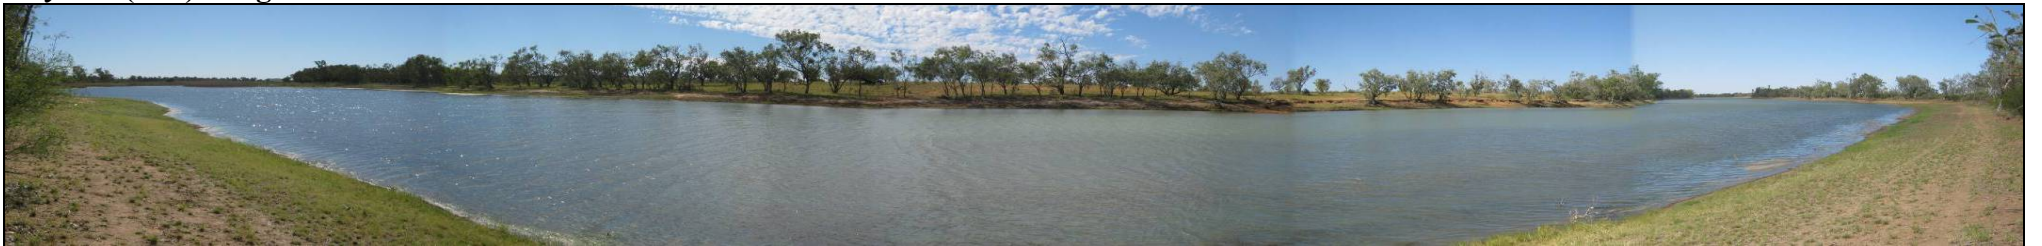
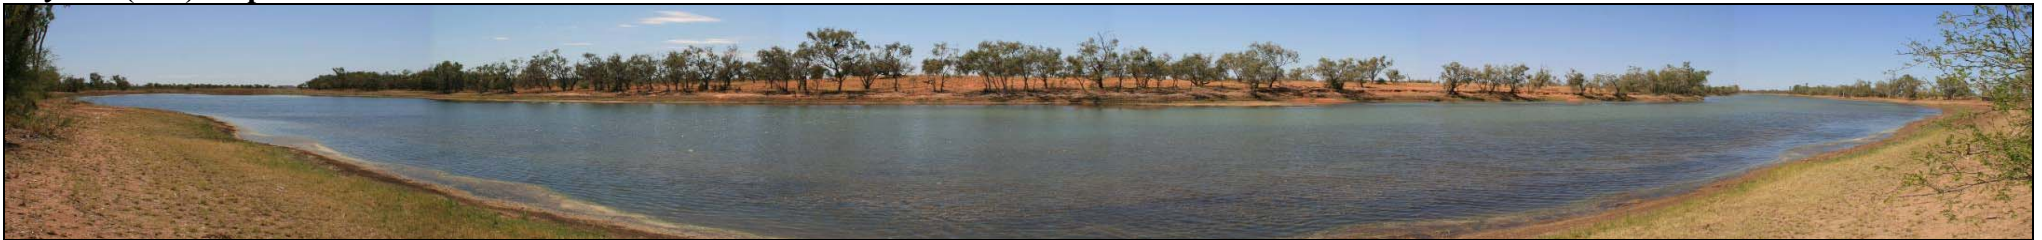
Jillyardi (JP1): November 2009

The photos from the *Jillyardi* permanent photo points show a good water level throughout the year, and some changes in water colour. These colour changes are believed to be caused by movement of the rainbow serpent spirit that lives in *Jillyardi*. The slightly lower water level and milky colour seen in pictures from November 2009 and late 2010 are due to the spirit travelling to other places, when he returns the water goes blue again. The changes in water colour seen throughout the photos did not surprise or concern the Gooniyandi people interviewed. TRaCK research conducted elsewhere across northern Australia, especially in the Mitchell River catchment, also showed that water quality parameters could be highly variable between seasons.

Water quality measurements at *Jillyardi* showed nothing to indicate concern. The green algae present in May 2010 at JP1 and JP2 is also a normal occurrence that the Bayulu-Gooniyandi Rangers says happens every year. Over the years they have observed the algae return and disappear again and believe it's a normal thing that people don't worry about. The photos over the span of a year also show how aquatic plants grow back after the wet season. Other TRaCK research looking at floodplain waterholes on the Fitzroy floodplain, as well as in other catchments across northern Australia such as the Daly and Mitchell floodplains, also indicate that aquatic algae are common at the end of the wet season and early dry season. There is strong evidence that this algae is a very important food resource for fish in these rivers: fish consume this algae at the end of the wet season and have a burst in growth which seems to support them through the following dry season.

Other concerns of the Bayulu-Gooniyandi Rangers are people poisoning or shooting the freshwater crocodiles. A dead freshwater crocodile can be seen at JP1 in May 2010. The Rangers suggested that poison meat (for pigs or wild dogs) had been laid too close to *Jillyardi*, and that this had killed the crocodile. There were also spent .44 magnum shell casings nearby; a calibre reportedly not in common use amongst Bayulu community members. The Rangers also considered that boats on the billabong posed a substantial risk, although there was no evidence that this happened during the trial monitoring program. It is believed the rainbow serpent doesn't like people putting boats onto *Jillyardi*, and those who disobey this rule will get the feeling of restlessness and may be in danger of getting hurt.

The Bayulu-Gooniyandi Rangers consider a management action for *Jillyardi* could include building a fence to stop the cattle accessing the billabong. They hope getting a trough for the cattle or finding permanent water somewhere else could allow a compromise to be reached with the station owners. One of the TRaCK research projects investigated appropriate methods for monitoring river health. This project found that while cattle disturbance appears to be a common impact on waterholes and rivers across northern Australia, there are very few places of "no impact" which could be used to compare impacts. Therefore, preventing cattle access to a waterhole is likely to provide a good opportunity to measure the impacts of cattle, particularly around these floodplain waterholes.

The Bayulu-Gooniyandi Rangers would also like signage put up at various locations around *Jillyardi* to inform and teach people how to use the billabong correctly. A draft of the sign has already been put together and is waiting for funding and a small amount of initial on-ground support. At the moment the weeds at *Jillyardi* are not a concern to the Bayulu-Gooniyandi Rangers

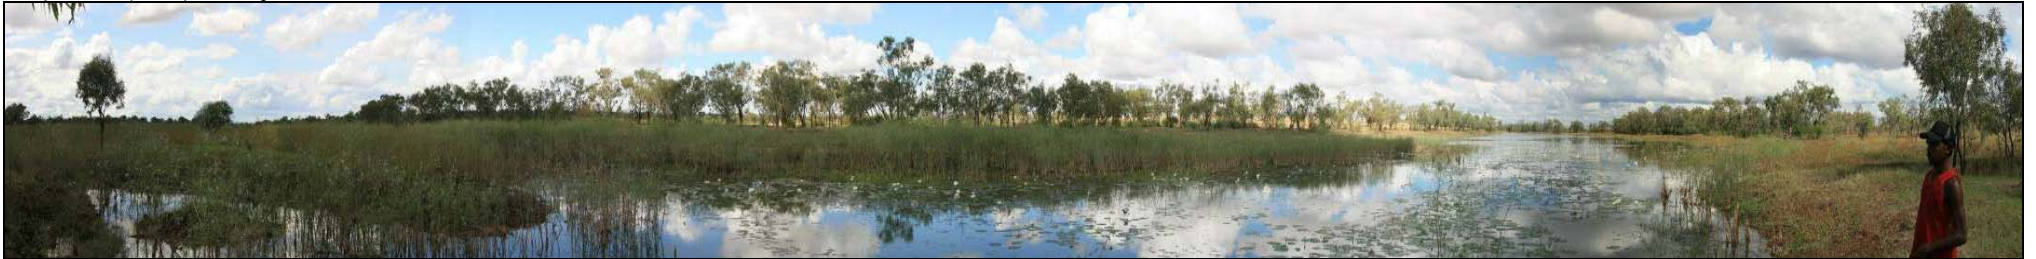
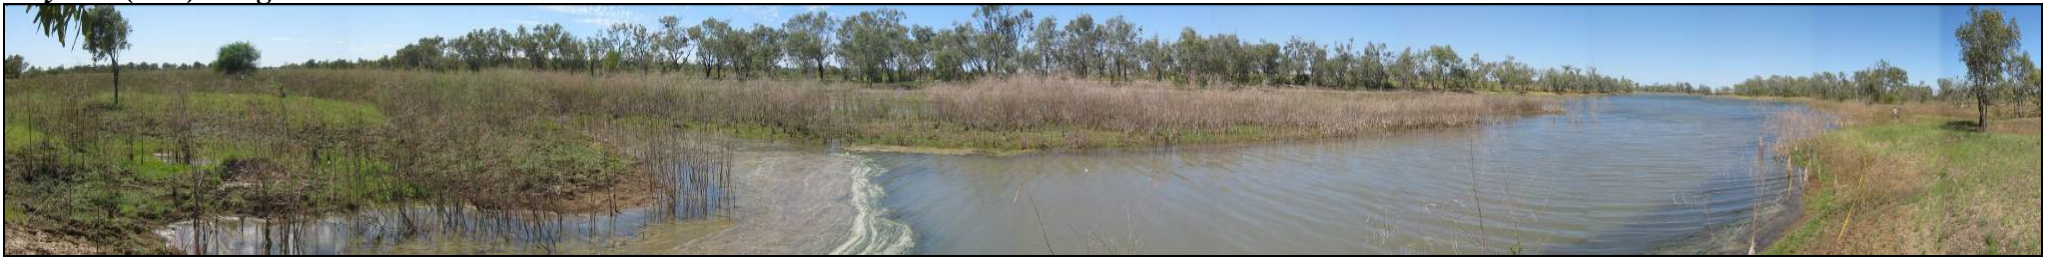
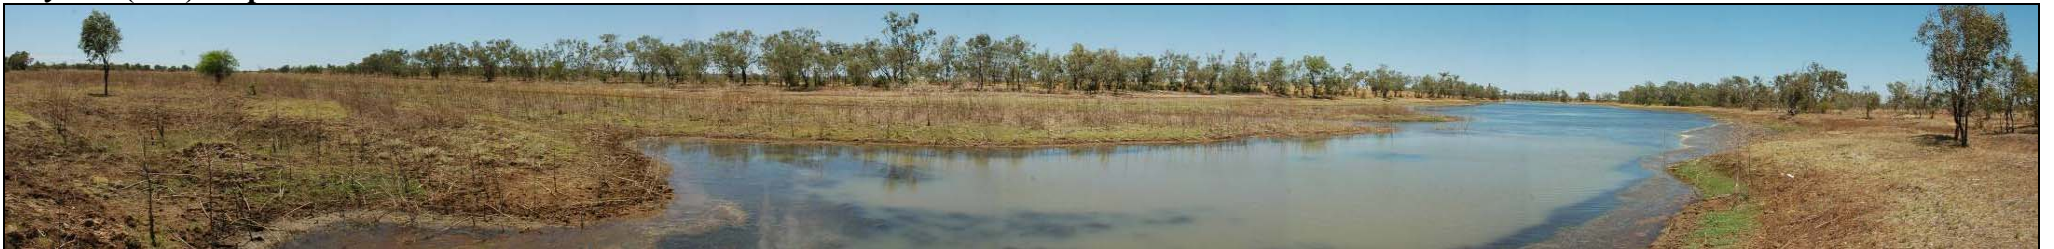
Jillyardi (JP3): May 2010

The photos taken at JP3 show the billabong getting drier towards the end of the dry season, although this is normal. The Bayulu-Gooniyandi Rangers explain that by September 2010 cattle and pelicans have made the water dirty at the northern end of the billabong (JP3). Currently, the Rangers are not concerned about the cattle and weeds present at the site, even though the weeds are relatively thick in this area.

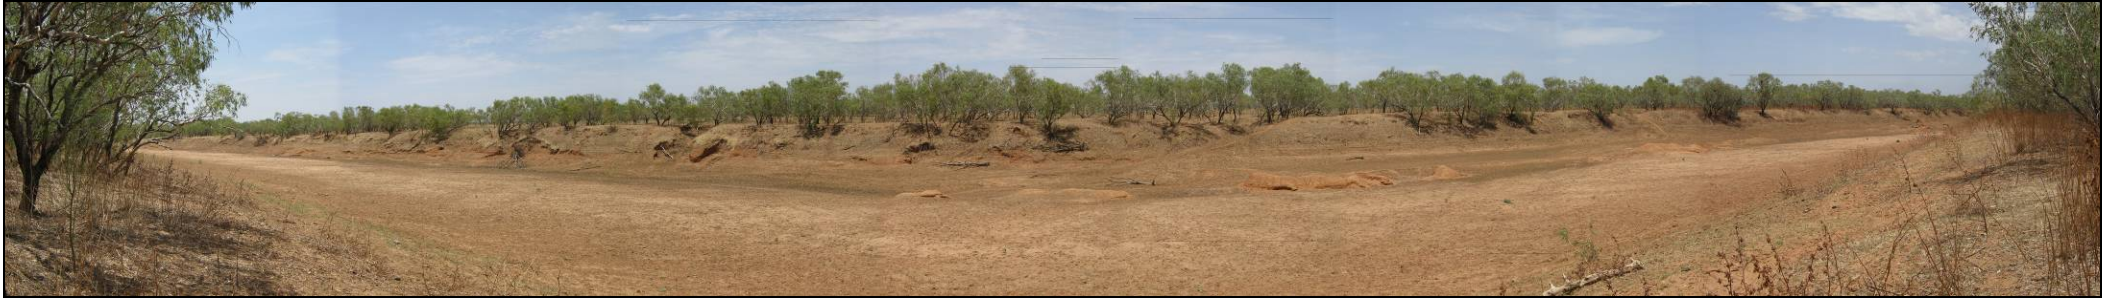
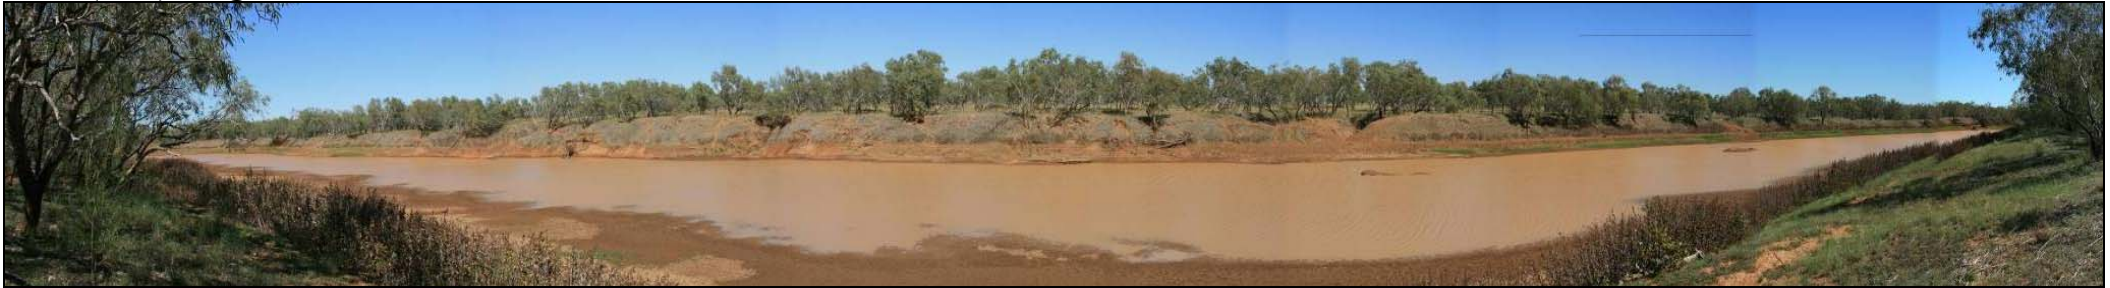
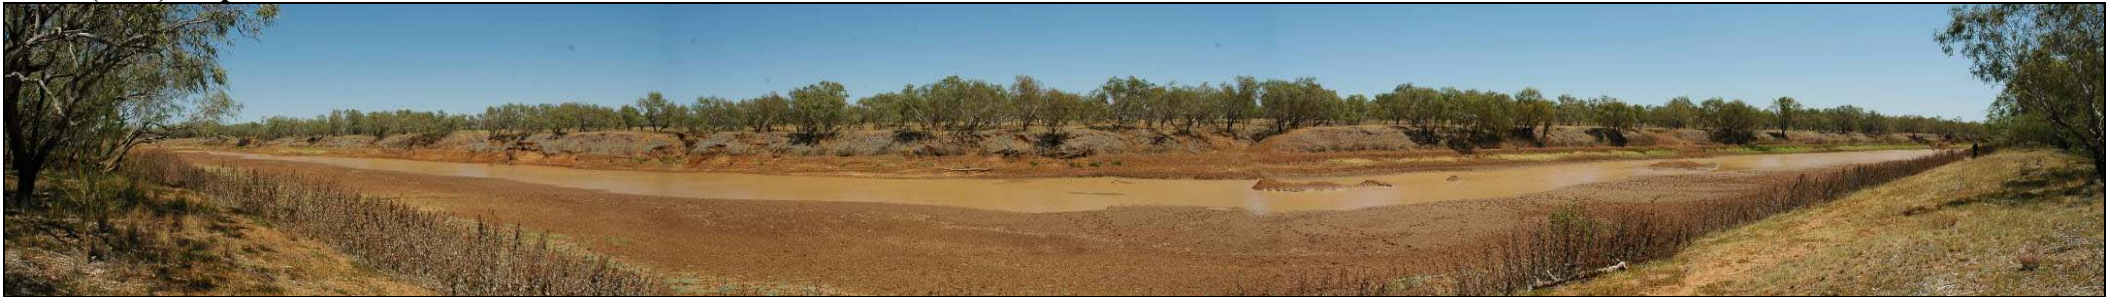
Garai (GP1): November 2009

At *Garai* one of the biggest concerns of the Bayulu-Gooniyandi Rangers is Noogoora Burr, which can be seen along the banks at both GP1 and GP2. The photos show that the Noogoora Burr dies back later in the dry season and during or after the wet season re-establishes itself on the banks. At both permanent photo points the Noogoora Burr is lower down the banks, which is a good thing according to the Bayulu-Gooniyandi Rangers, and it looks like the cattle have knocked some of it down. The Rangers suggest that as the 2009-2010 flood was of a smaller magnitude than 2008-2009, the water deposited Noogoora Burr seeds further down the bank, reducing the amount of Noogoora Burr growing along the top of the bank where people camp.

Although water quality monitoring showed extremely high levels of turbidity in *Garai*, the Bayulu-Gooniyandi Rangers believe the water shown in the photos is satisfactory. They explain how the water goes clean after the wet season flood and then the wind makes it dirty, before the site dries in preparation for the next flood season. Other TRaCK research in similar waterholes on the Mitchell River floodplain also show that water quality, particularly turbidity, can vary greatly between the late wet season after the floods and the late dry season. These patterns were observed in waterholes where there was no impact from cattle or pigs, suggesting the water quality in floodplain waterholes can be highly variable.

The major concern of the Bayulu-Gooniyandi Rangers at *Garai* is the Noogoora Burr. Currently they are unsure how to manage the weed and would like to be trained in its removal. They would then like to generate a management action for its exclusion. The Bayulu-Gooniyandi Rangers would like the future condition of *Garai* to include at least a small area free of Noogoora Burr that can be used for camping and day trips.

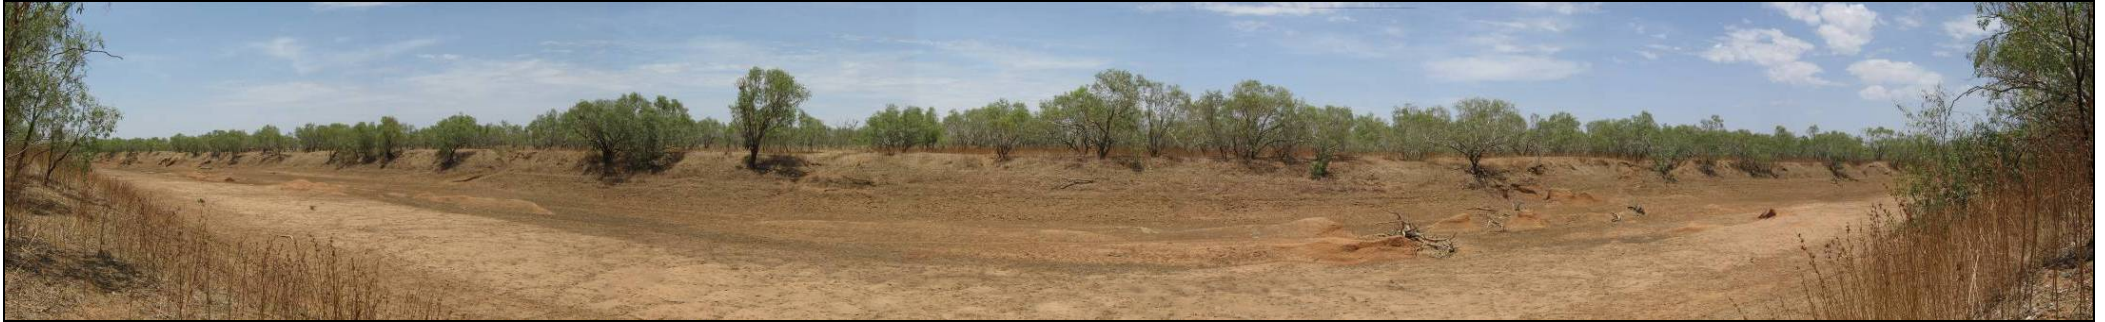
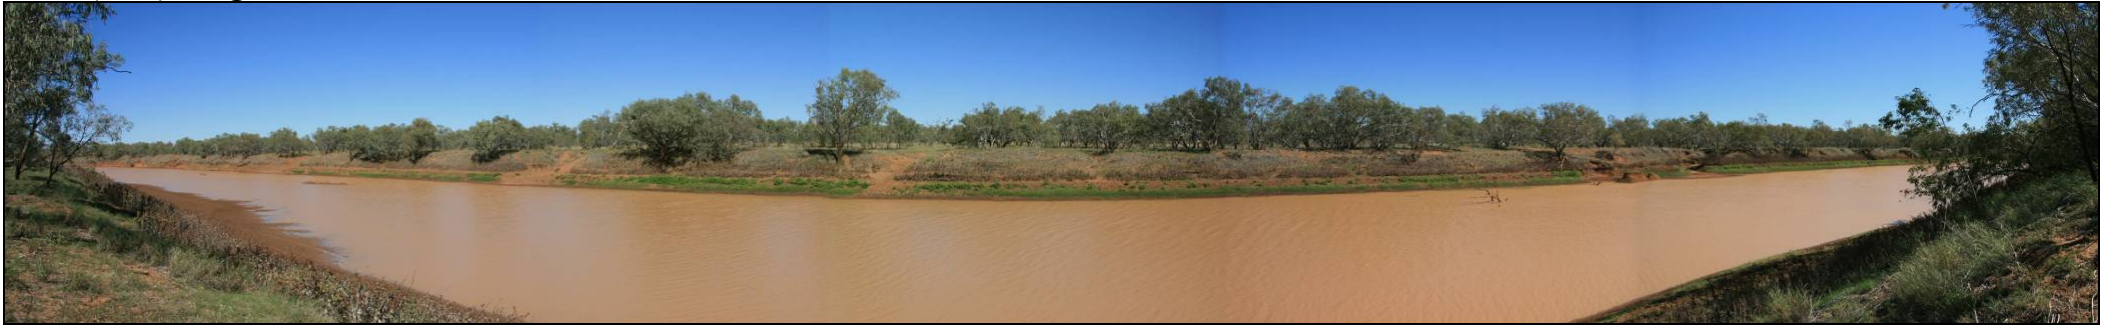
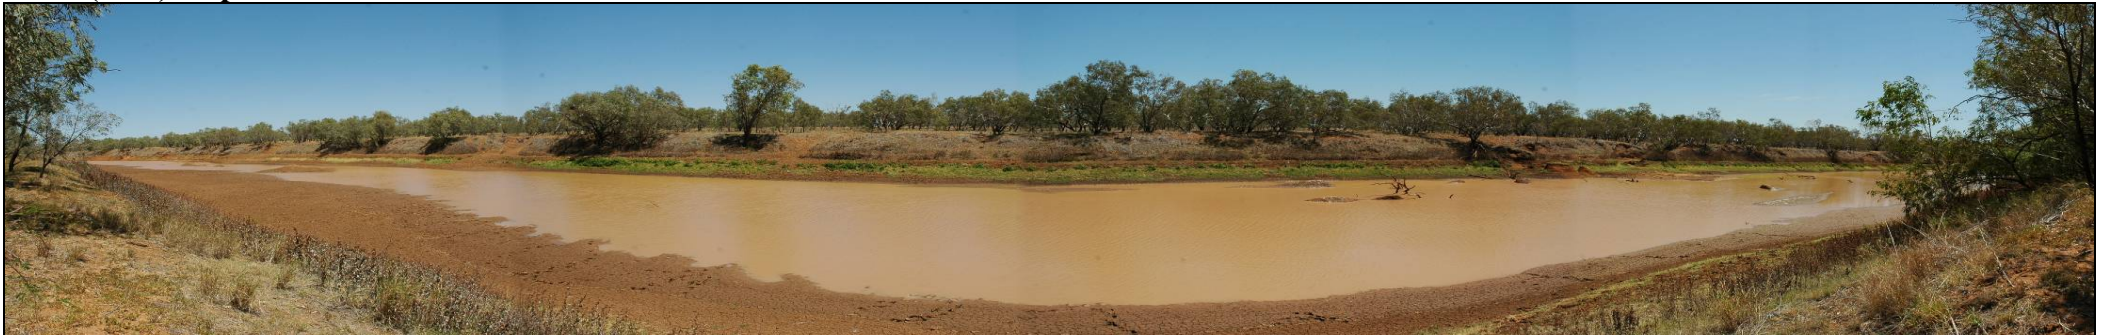
Garai (GP2): November 2009

The GP2 August 2010 photo shows multiple cattle paths down the other side of the creek bank, which the Rangers suggested was normal and not of concern for *Garai*. The Rangers did express the opinion that the cattle tracks may encourage erosion, but *Garai* appeared to be considered an acceptable watering point for stock. According to the Bayulu-Gooniyandi Rangers there also used to be many more pigs in this area than was the case during the trial monitoring program.

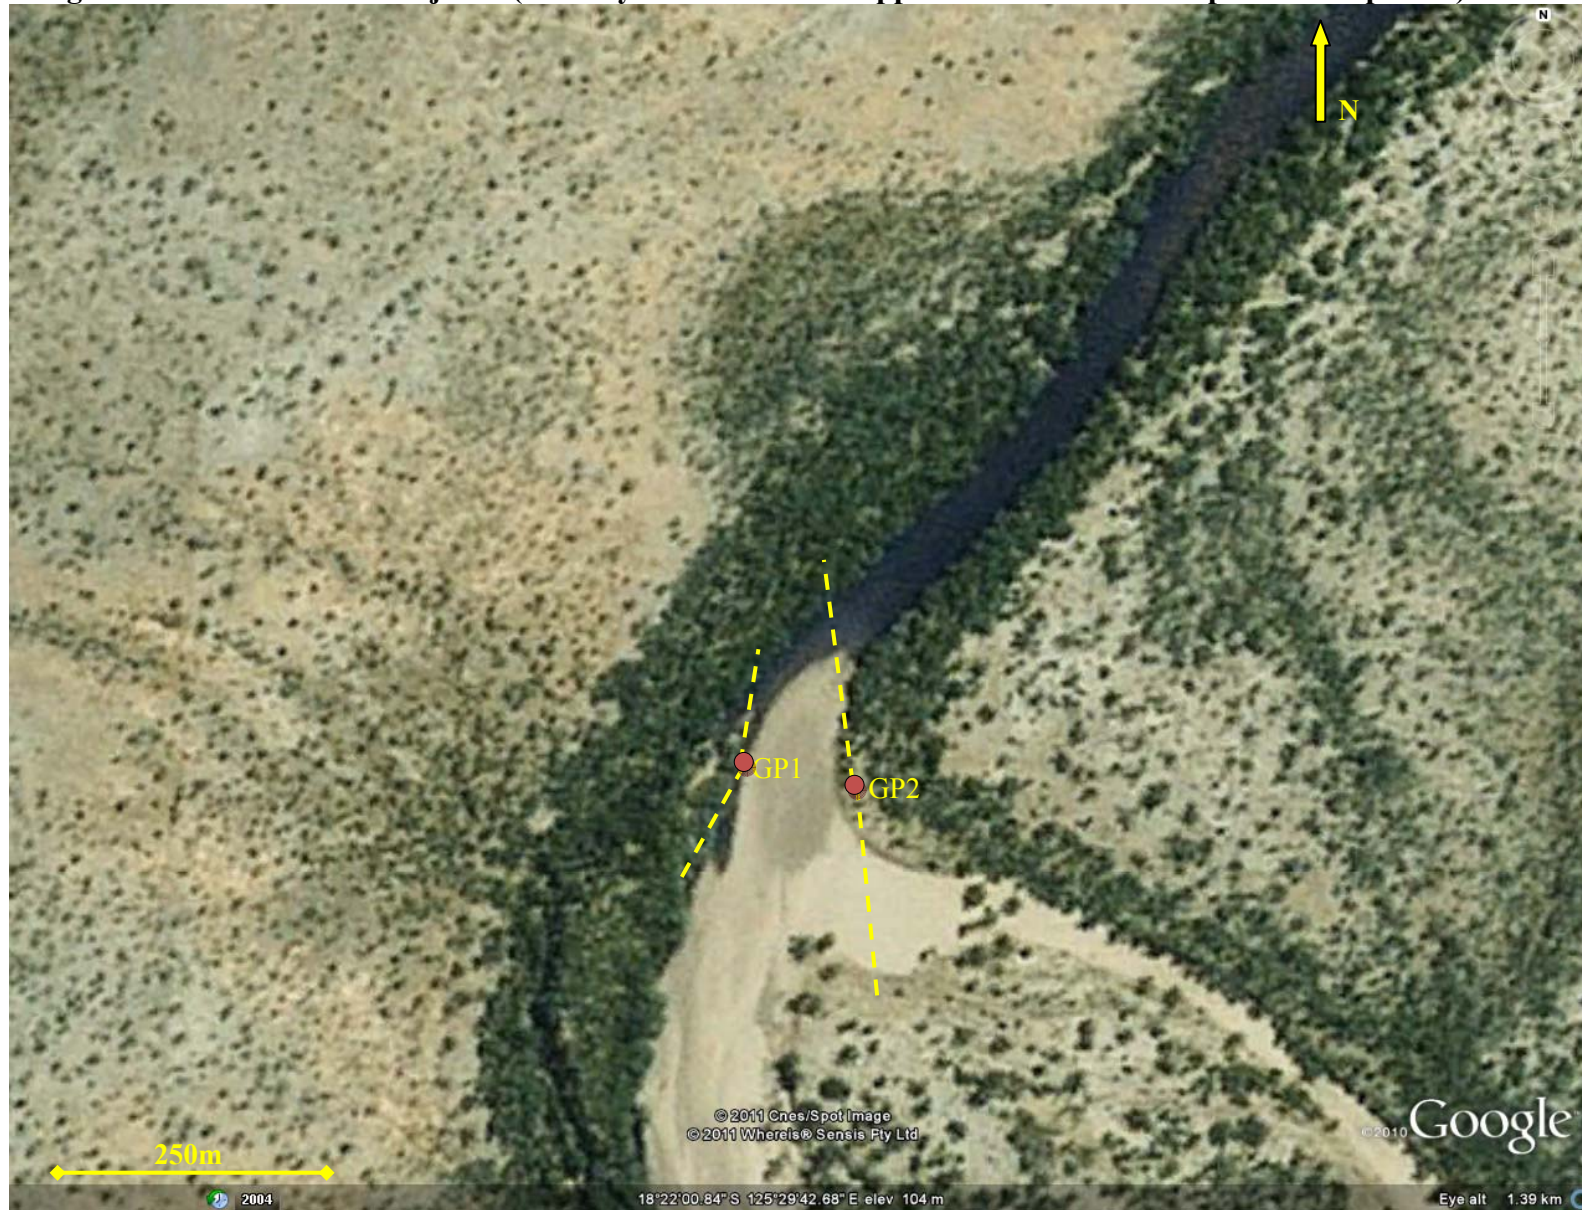
Google Earth™ view of Winadjibun (dotted yellow lines show approximate direction of permanent photos)

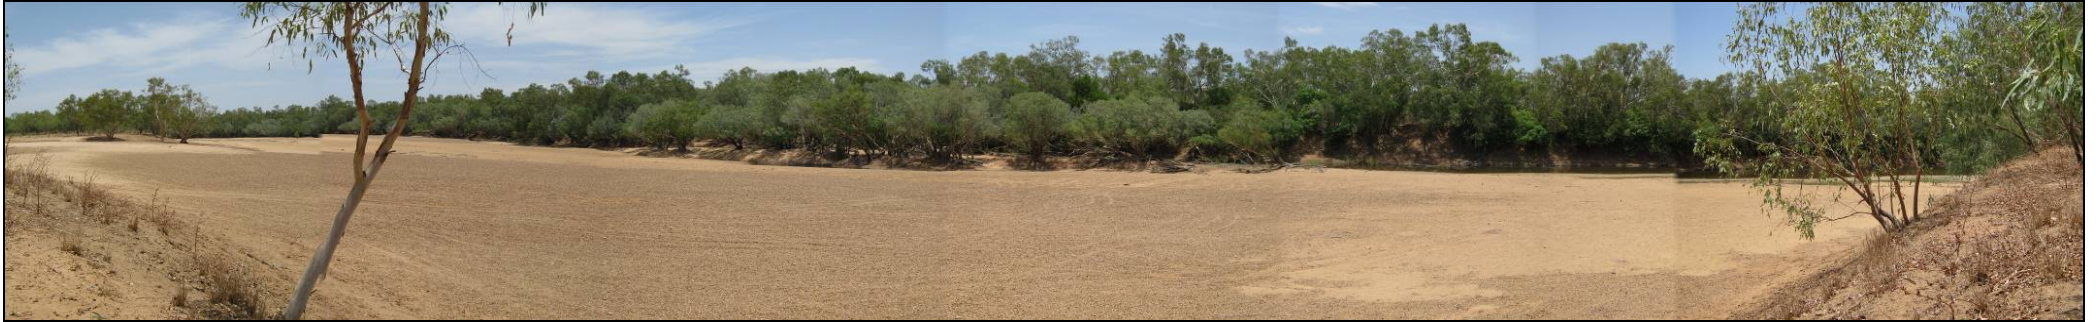
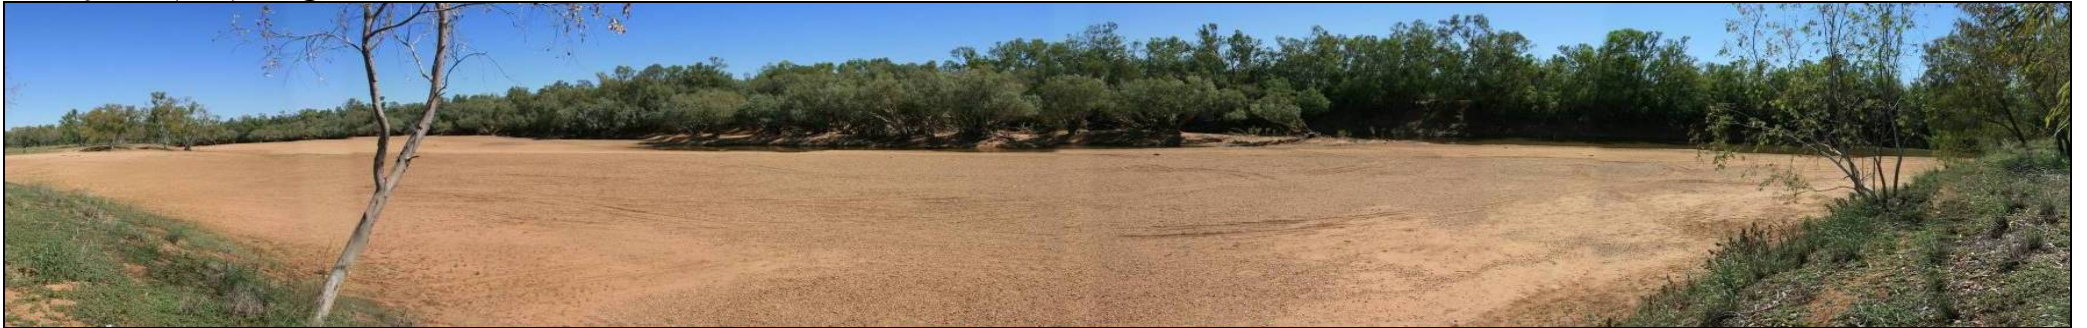
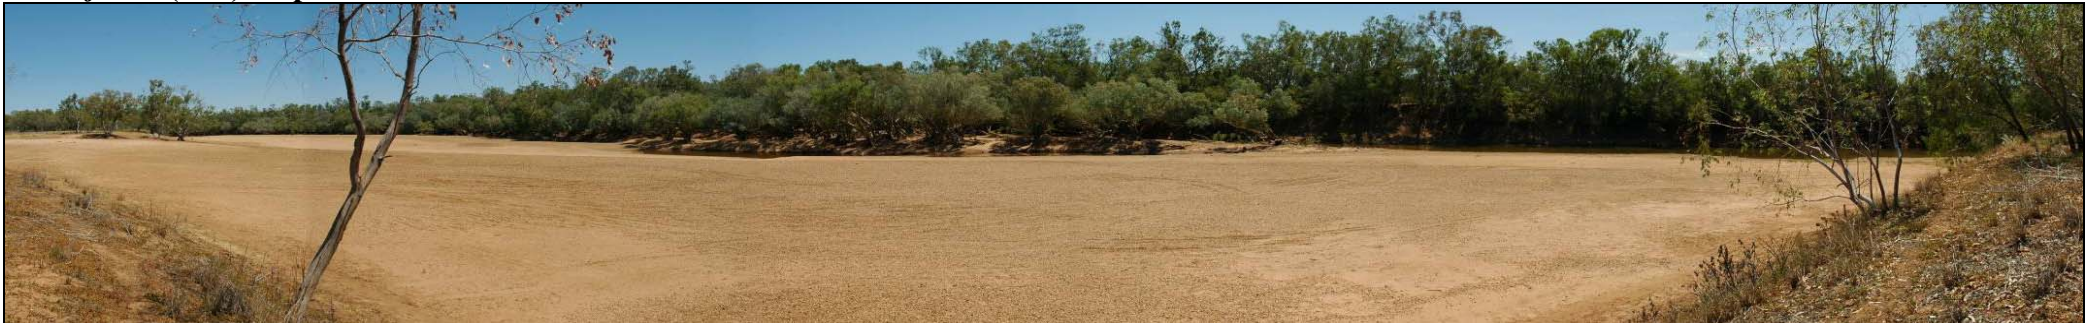
Winadjibun (SP1): November 2009

At *Winadjibun* prior to the monitoring program starting in 2009 the sandbar was all sand and no rocks according to the Bayulu-Gooniyandi Rangers. They believe that over time the wet season floods have pushed or washed some of the sand out and exposed or deposited more rocks.

The photos taken at SP1 show little, if any, Noogoora Burr present in November 2009. However, it can be seen in the 2010 photos. At this photo site the Bayulu-Gooniyandi Rangers believe Noogoora Burr is becoming a problem.

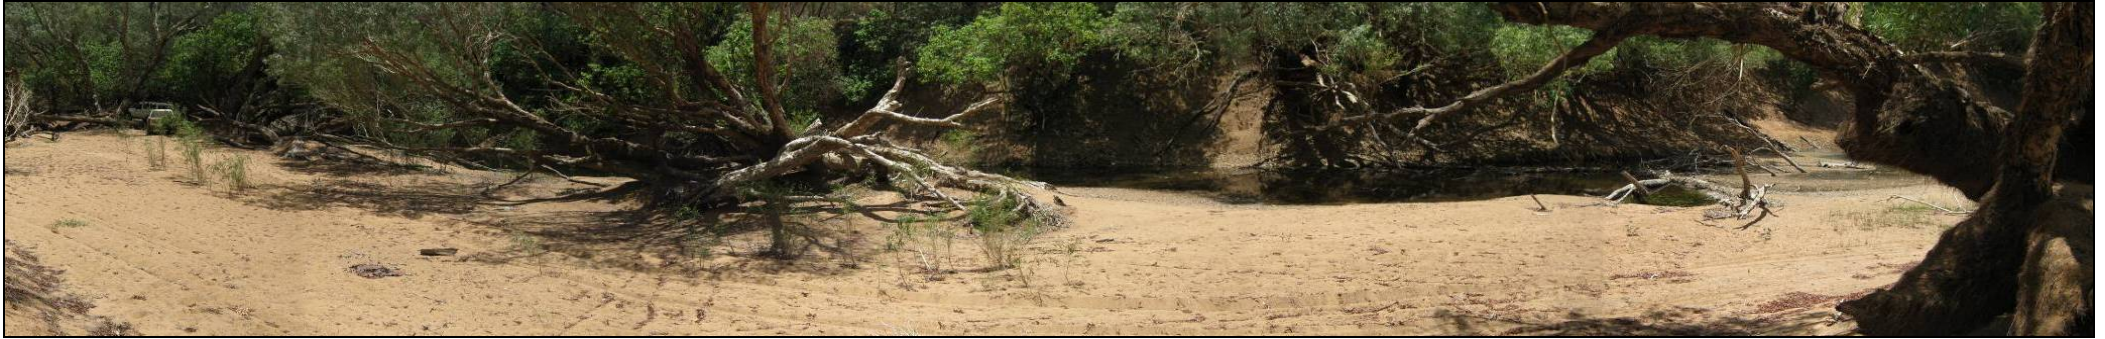
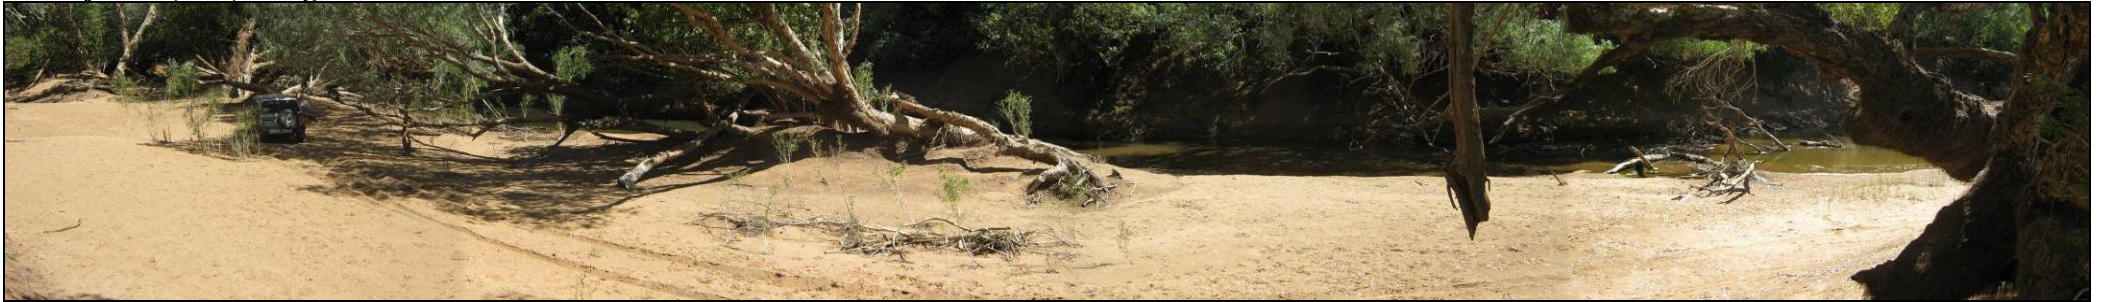
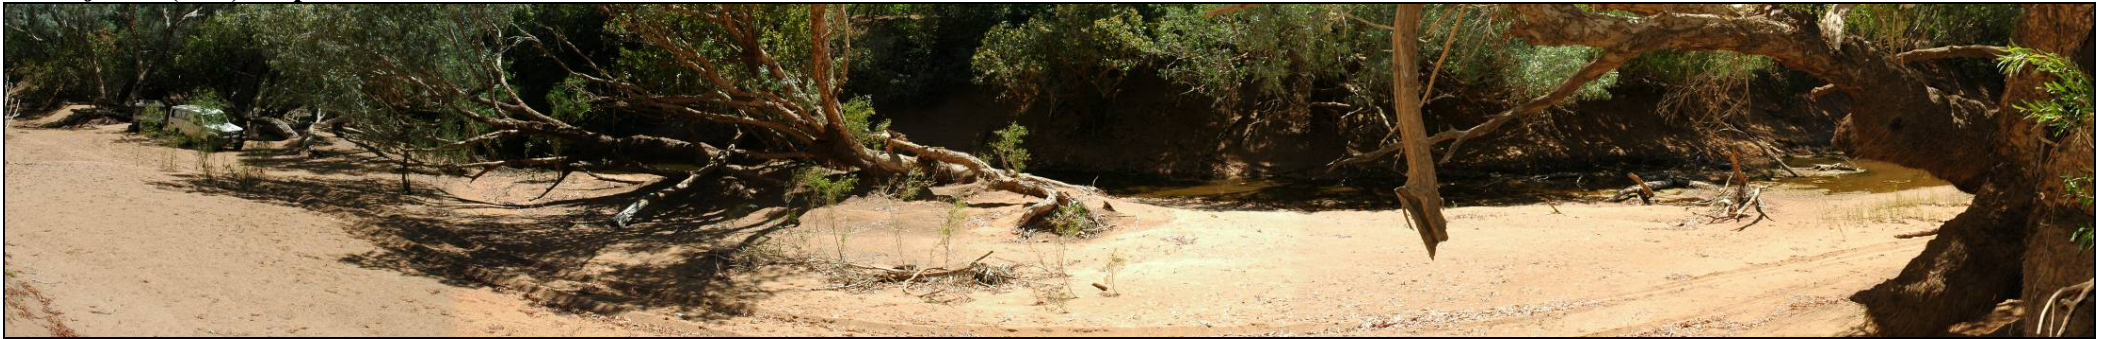
Winadjibun (SP2): November 2009

According to the Bayulu-Gooniyandi Rangers, the photos of SP2 show a dry site due to little rain. During and after the flood the water runs along the both sides of the trees shown in the middle of the photo. The rangers recall *Pandanus aquaticus* used to line the river bank at SP2 and are not sure what event made them disappear. The Rangers believe people littering is currently the main problem at this site.

The Bayulu-Gooniyandi Rangers are happy about the current condition of *Winadjibun* and believe there are not any substantial issues beyond the constant littering of the site. Suggested management actions include placing a sign and temporary rubbish bin at the site. A sign for *Winadjibun* has already been drafted and is waiting for funding and a small amount of initial on-ground support. The Bayulu-Gooniyandi Rangers would also like to be able to provide rubbish bins at *Winadjibun* during big meetings and culture camps and coordinate their removal after the event to insure the site is kept clean.

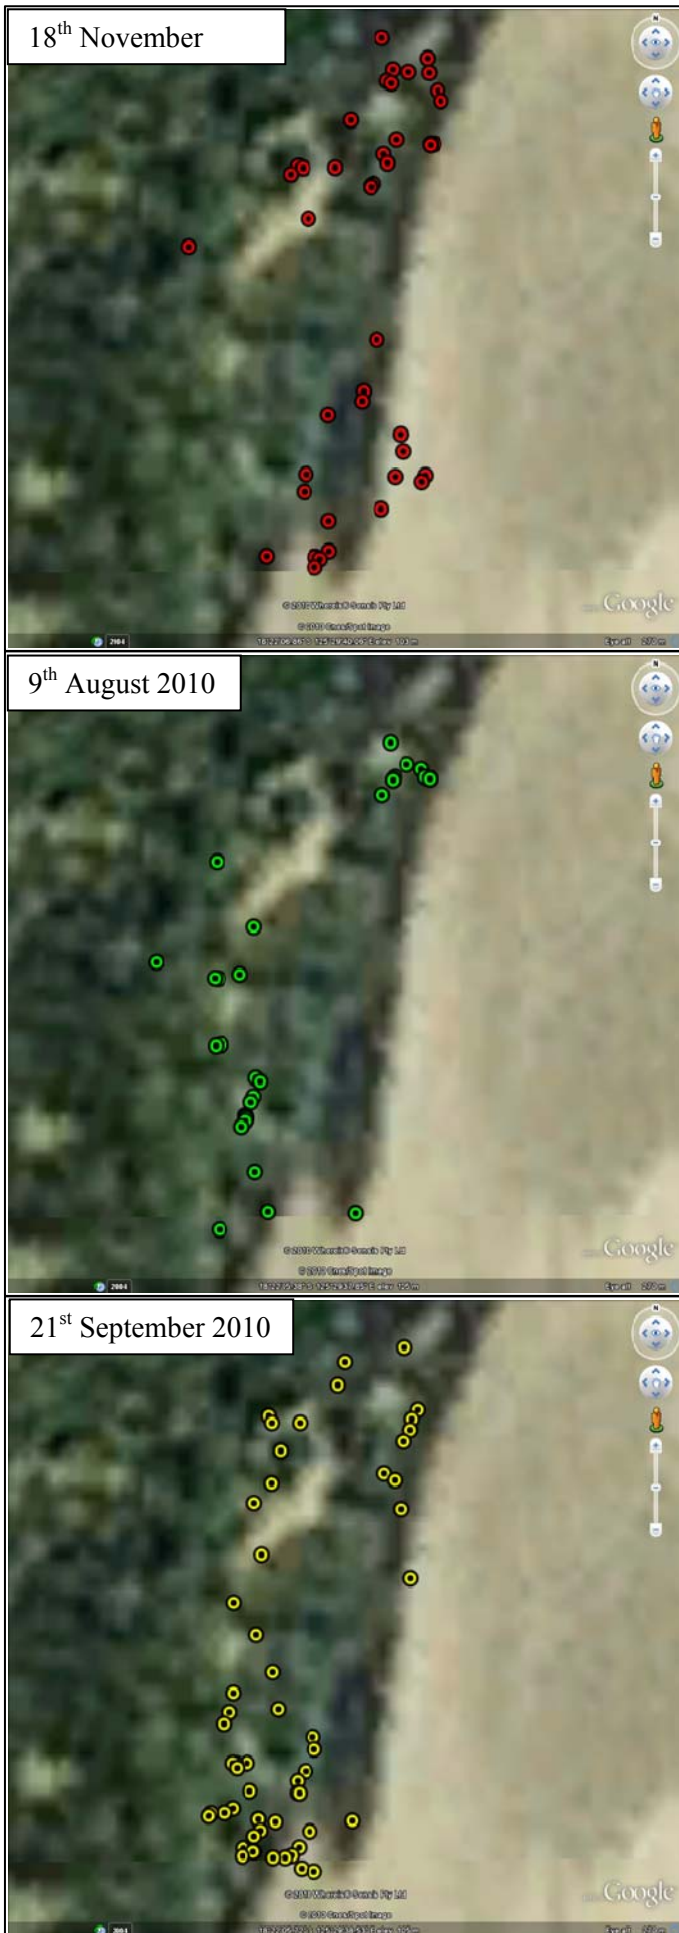
The GPS coordinates for rubbish at Winadjibun show that leaving rubbish behind was a continuing problem throughout the monitoring trial.

The number of marks on each of the Google Earth™ images on the left reflect the number of items of rubbish (and so, density/intensity of the rubbish).

*On 18th November 2009, **46** items of rubbish were counted and collected.*

*On 9th August 2010, **31** items of rubbish were counted and collected.*

*On 21st September 2010, **51** items of rubbish were counted and collected.*
