Northern Australia
Environmental
Resources
Hub

Developing a *Yawuru bilarra* (wetland) monitoring program

Report

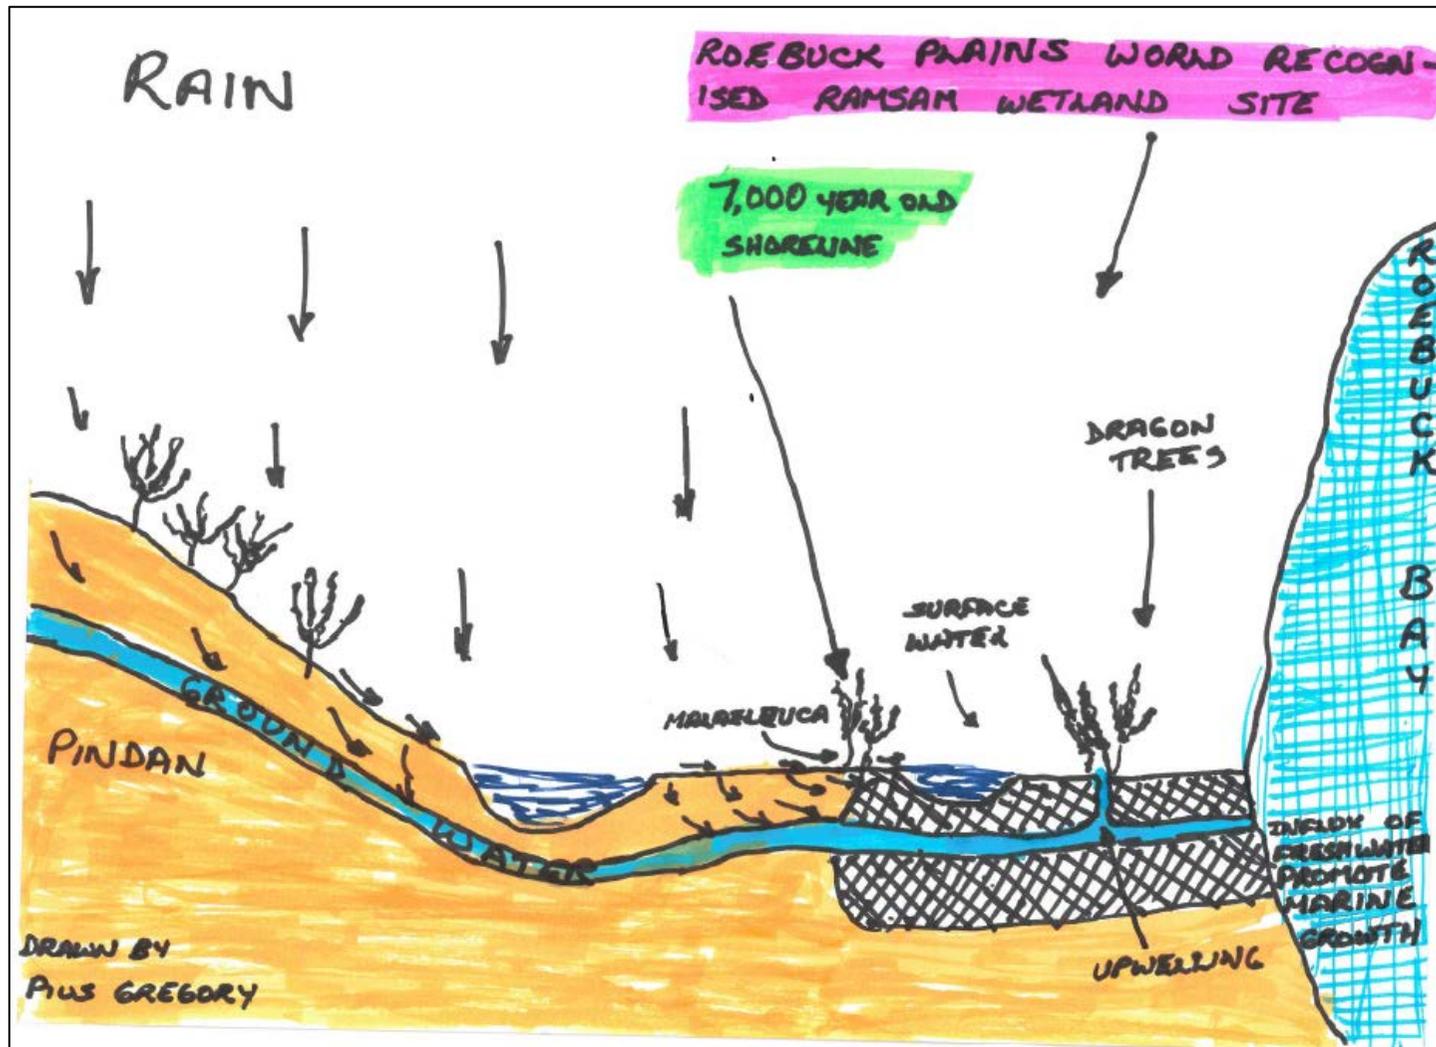
Based on his work with Vic Semeniuk (see Semeniuk 2014 for more detail), Pius Gregory (Traditional Owner and Country Manager) developed a diagram which summarises how the different types of *bilarra* are formed and connected to Roebuck Bay (Figure 3-1). *Bilarra* such as Lake Eda and Ungani are reliant on rainfall runoff from drainage lines, while other *bilarra* are formed by more localised runoff including Lake Champion and Taylors. Soaks and springs occur around the edge of the plains (melaleuca zone or *murruga yirr garnburr* zone), where groundwater is pushed up when the sands meet the marine plain mud and other springs are formed through cracks (Pius Gregory, NESP 29th August 2018).

Figure 3-1. Roebuck Plains bilarra formation and connection to saltwater, drawn by Pius Gregory, Yawuru Traditional Owner for this project, based on his knowledge of the Plains and the knowledge he has gained from working with Vic Semeniuk. Yellow represents sand and black hatching represents marine plains mud.

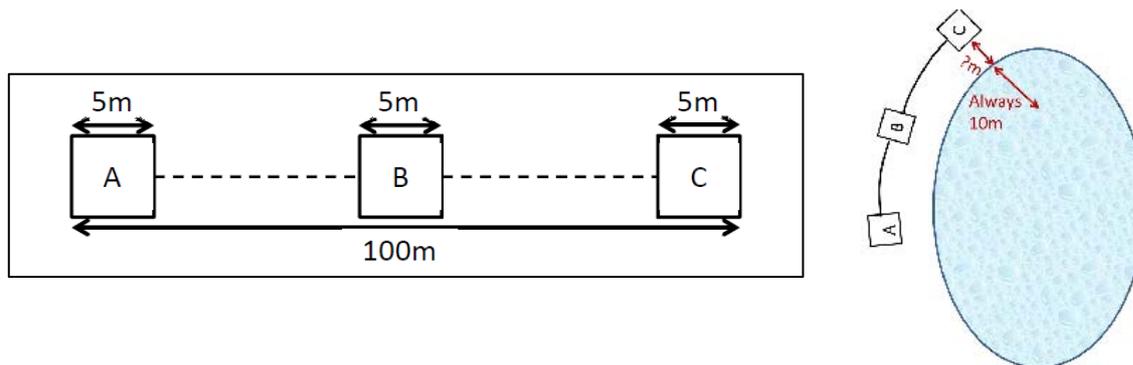
Multiple transects were located at each *bilarra*. The location of these transects were chosen by the CMs to include areas of concern (for example that were being eroded or had trees that appeared unhealthy) or to capture culturally important species, for example *lardig* (freshwater mangroves) at Lake Campion.

Figure 5-2. (a) Layout of the 100-m riparian transect and three 5-m quadrats and (b) layout of the transition zone transect.

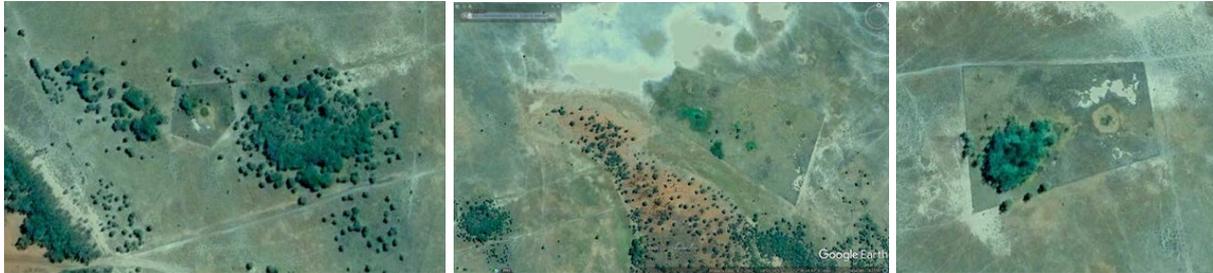
Pius described how the Roebuck Plains Station previously fenced some small springs over 20 years ago. Satellite photos reveal old fencing lines at three spring sites (Figure 6-2).

Figure 6-2. Satellite imagery from Google Earth showing old fencing: (a) (now) unfenced spring (2012), (b) western enclosure (2002) and (c) eastern enclosure (2002).

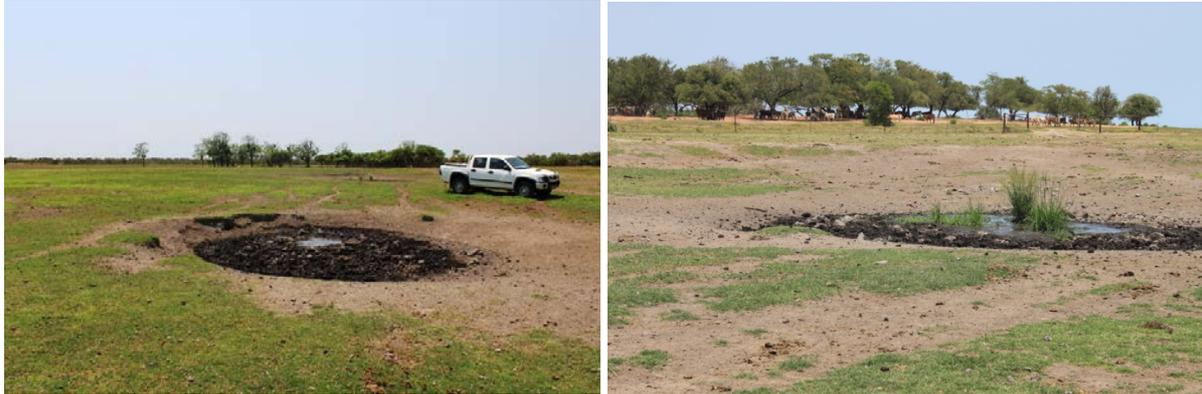
The CMs have seen significant changes at *Mimiyagaman* with the changes clearly demonstrating the benefits of cattle management and fencing. Pius described how before the fence was put in (Figure 6-4), *Mimiyagaman* was ‘...flogged by cattle. Today you can see a lot of difference. The cattle were eating the dragon trees as far as they could get their mouths, and the ground was all bare, it was a dust bowl.’ (Pius Gregory, NESP field trip 28th August 2018).

Figure 6-4. Photos showing cattle impacts within the main *Mimiyagaman* enclosure in 2012 (western enclosure) (photo D. Mathews).

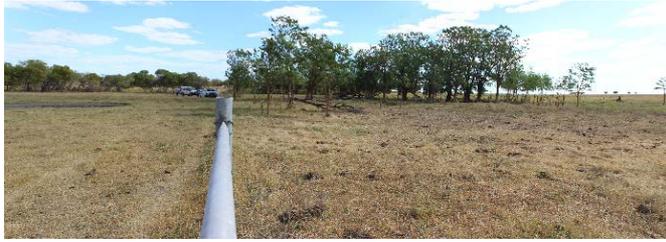
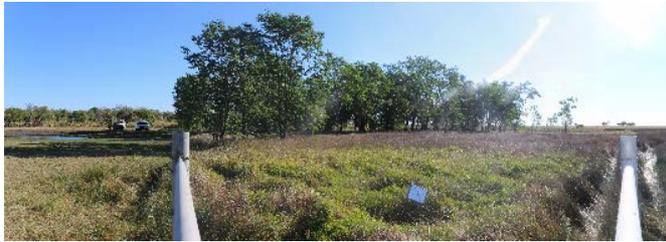
Photo point monitoring at the western enclosure commenced after the main fence was in place. In 2014, cattle were able to access the site through a broken fence. Once fixed, the photos show how the groundcover inside the fence line recovered over the next three years (Figure 6-5). Photo points also show how the groundcover inside the fence line extension recovered over the first year (Figure 6-6).

Figure 6-5. Photo point PMIM1 showing groundcover recovery from Bargana (winter) 2015 to Bargana 2017 within the western Mimyagaman enclosure. The fence was erected in 2013, but cattle gained access to the fenced enclosure in 2014 and were then removed in 2015. First photo 2/7/2015, second photo 6/6/2017.

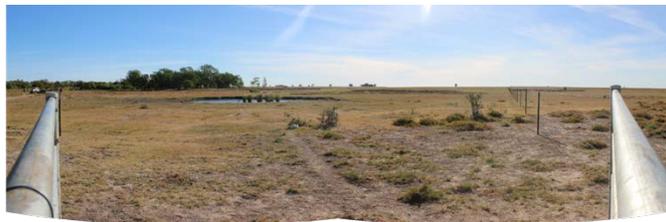
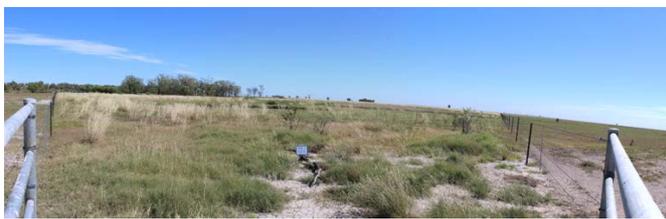
Figure 6-6. Photo point PMIM5 showing groundcover recovery from Bargana (winter) 2017 to Bargana 2018 in the extended fence at the western enclosure. This extension was erected in 2017. First photo 6/7/2017, second photo 15/5/2018.

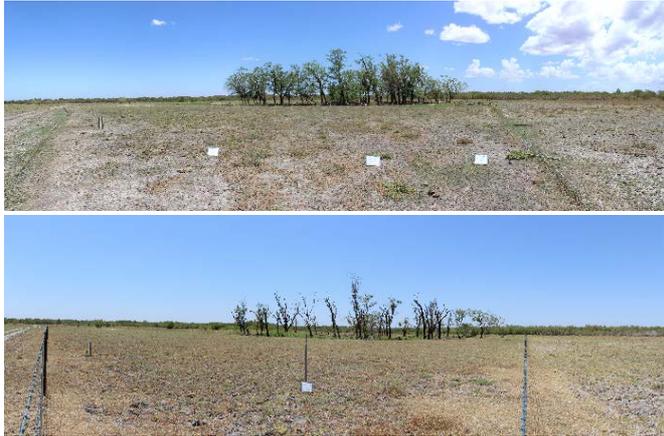
Figure 6-7. Photo point PMIM4 showing loss of Dragon trees following the 2017–18 flood. Photos taken 16/12/2015 and 20/10/2018.

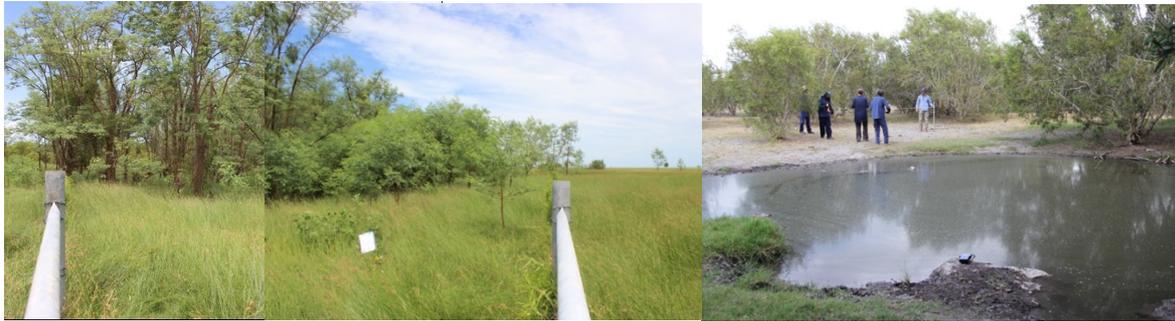
Figure 6-8. (a) Photopoint PMIM1 (May 2021) showing a significant increase in plant cover and regeneration compared to pre-transect photos (shown in Figure 6-5) and (b) unfenced spring at Mimiyagaman showing muddy (turbid) water, cattle trampling and areas of bare ground.

how they can ensure the Zone 1 area (outside of the fenced springs) can be managed and the CMs are now considering fencing the unfenced spring as it is the only spring in the area not protected.

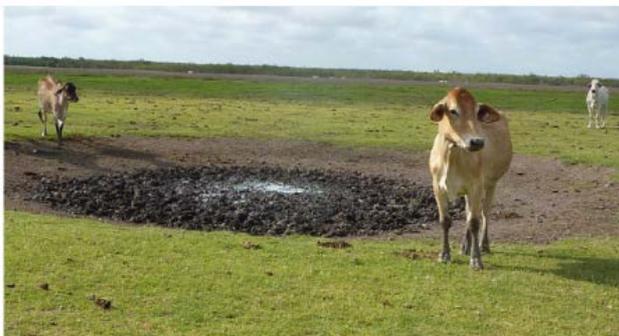
As with Mimiyagaman, in 2012 Willing (2012) detailed that 'many small spring systems on the edge of Roebuck Plains are in ecological decline (major bark damage on Dragon Trees, no active recruitment and fencing not maintained) from both cattle impacts and groundwater changes' (Figure 6-10).

Figure 64: Trampling of groundwater spring by cattle

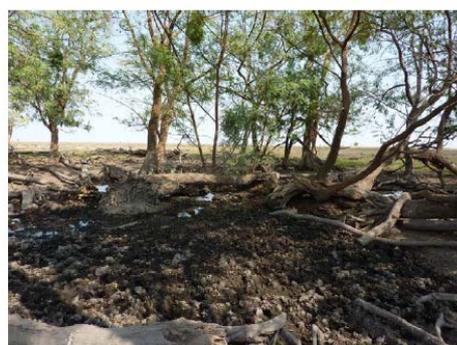
Figure 6-10. Wetland areas within the main enclosure and eastern enclosure (from Willing 2012).

Figure 53: Copse of *Sesbania formosa* around spring

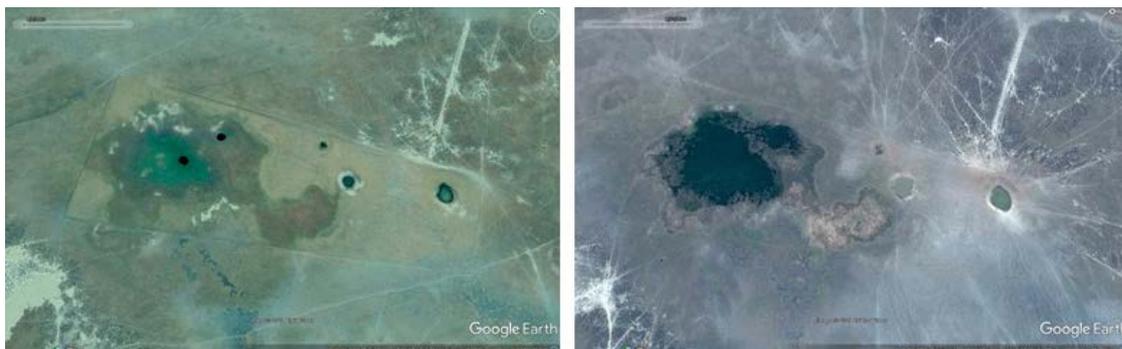
Although some of the springs with Ram Paddock have previously been fenced by the station (Figure 6-11) these fences were not maintained when the pastoral station review (Willing 2014) and ESRM report were conducted (Biota 2015).

Figure 6-11. Satellite imagery from Google Earth showing the main Ram Paddock spring site: (a) fenced in 2002 and (b) fence not maintained with cattle tracks throughout the spring (2010).

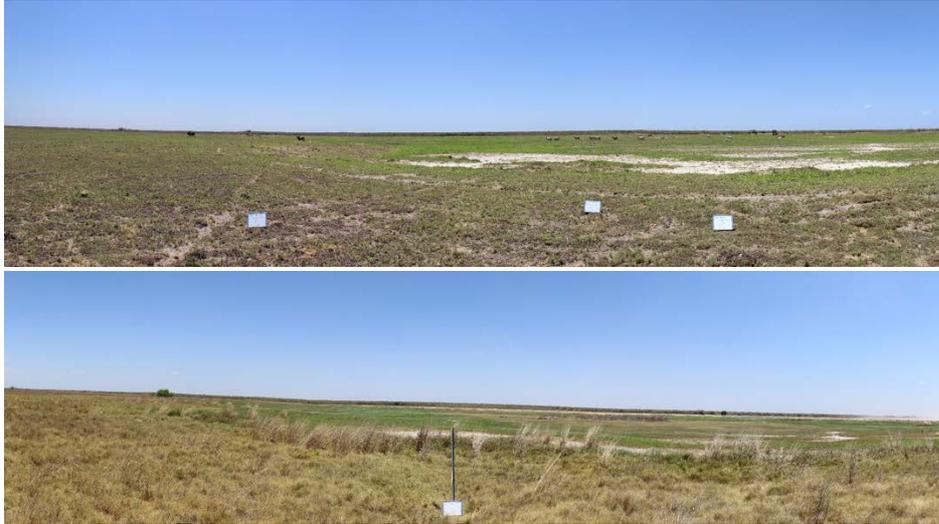
Within the main enclosure at RAM Paddock the CMs have noted that *rirrwal* are finally recruiting (new dragon trees starting to appear) 'Prior to the fencing there was only one dragon tree left. Now there are several patches where dragon trees are starting to regrow (Pius Gregory August 2018). The CMs also described how before the fence the area was a 'dust bowl, there was no grass'. Now different plant species cover the ground, with grass and saltbush species (Figure 6-13).

Figure 6-13. Photo point PRAM3 Dragon Tree Soak looking into middle of main fenced paddock (near VRAM 2). First photo 16/12/2015 cattle still in area, second photo 17/10/2017.

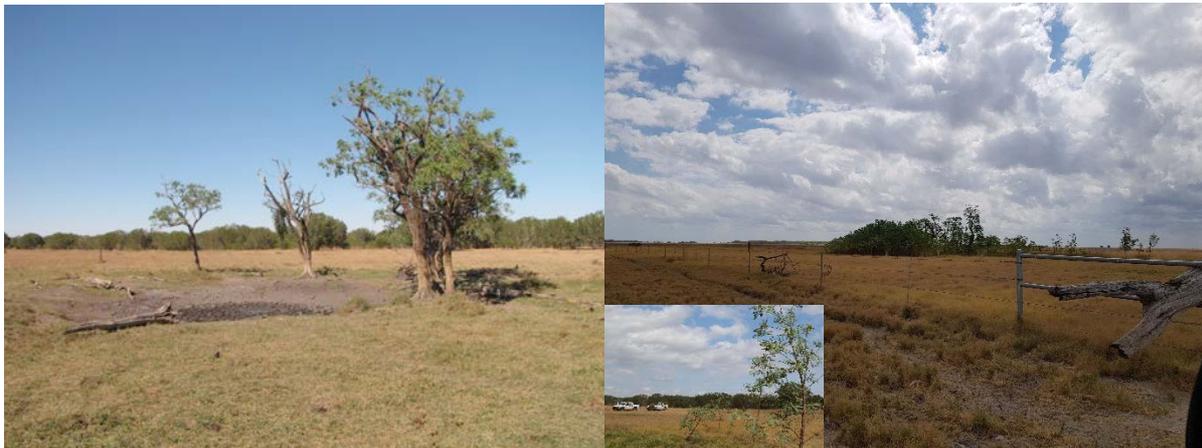
The eastern enclosure previously had only several large *rirrwal* but now has 'hundreds of resprouting *rirrwal* (Figure 6-14 and Figure 6-15).

Figure 6-14. Photos showing the difference within the eastern enclosure: a) 'senile *Sesbania formosa* trees on a degraded waterhole near Ram Paddock' (from Willing 2012) and (b) a photo taken while visiting this site on the NESP field trip August 2018 (Ram 1) showing the recruitment of *rirrwal* at this site following CM fencing.

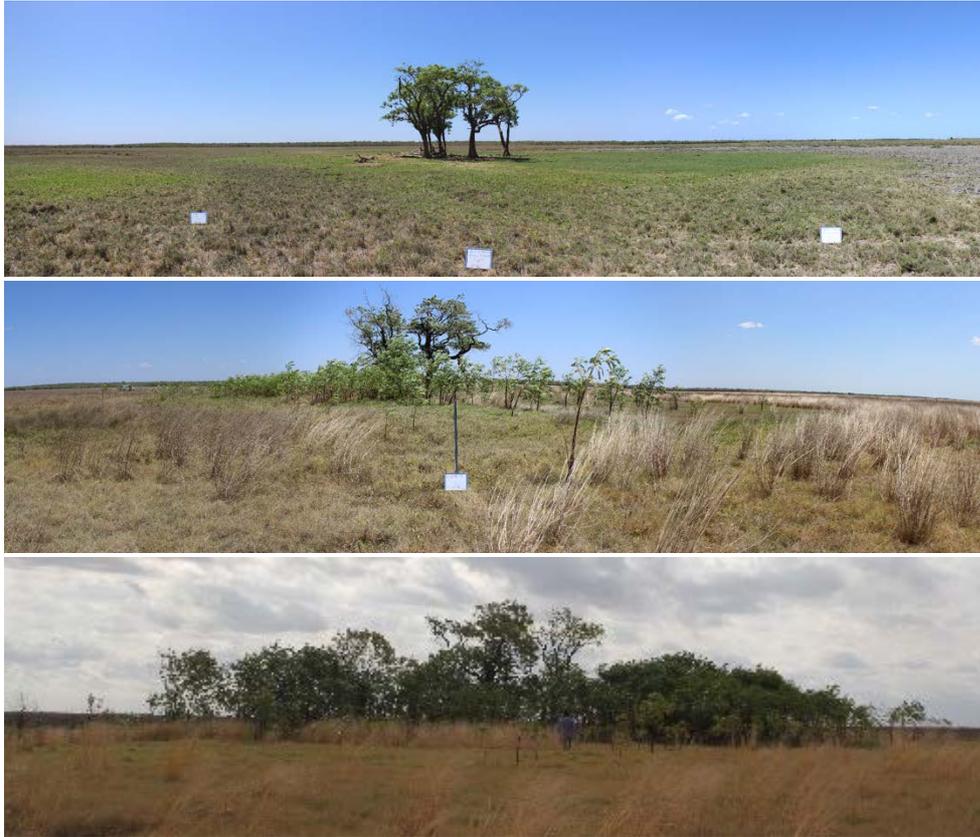
Figure 6-15. Photo point PRAM1 showing dragon tree recovery at the eastern enclosure between 2015 and 2017. This site has been fenced we marked as a potential site but there was no water. First photo 16/12/2015, second photo 22/11/2016, third photo 17/20/2017.

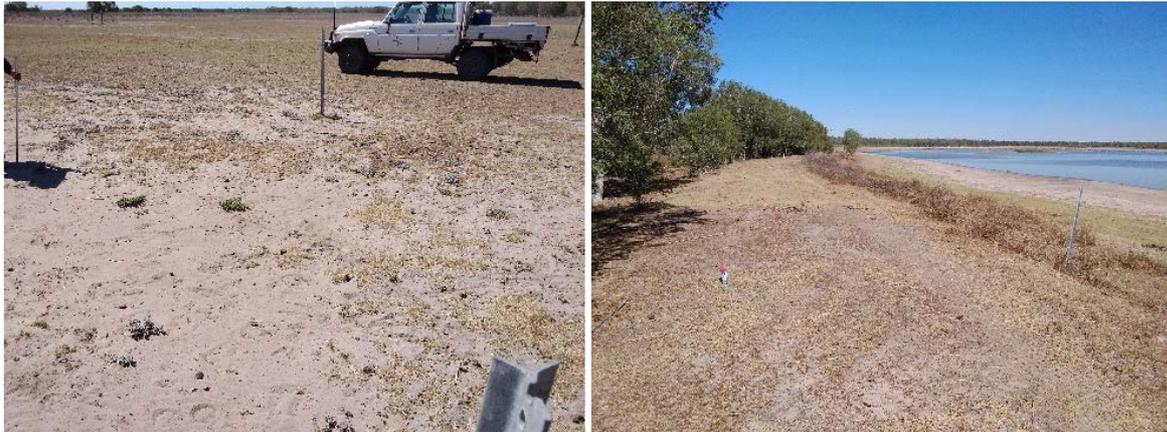
Plant cover (score)	Plant cover is currently low with large areas of bare ground.	Current cattle stocking rates impacting on plant cover. CMs planning to discuss with the station manager and determine if this is a result of management or fencing issues.
Regeneration (score) -if new young trees are growing to replace older trees.	Regeneration score at <i>Yidarr</i> consistently low.	Current cattle stocking rates impacting on regeneration. CMs planning to discuss with the station manager and determine if this is a result of management or fencing issues.
Weeds (score)	No weeds recorded within transects	Longer-term monitoring will pick up any new weed species which will be considered under Yawuru's weed management program
Impacts Cattle Fire Other impacts	Scores for cattle impacts at all transects are high (including scats, trampling, and cropping of plants)	Fencing or cattle stocking rates not effective (see comment above)

Figure 6-19. Photos demonstrating impacts from cattle trampling and low levels of plant cover within the transects along the western edge of the lake and the eastern edge up to the murruga yirr garnburr zone (VEDA2 and VEDA3 October 2020)

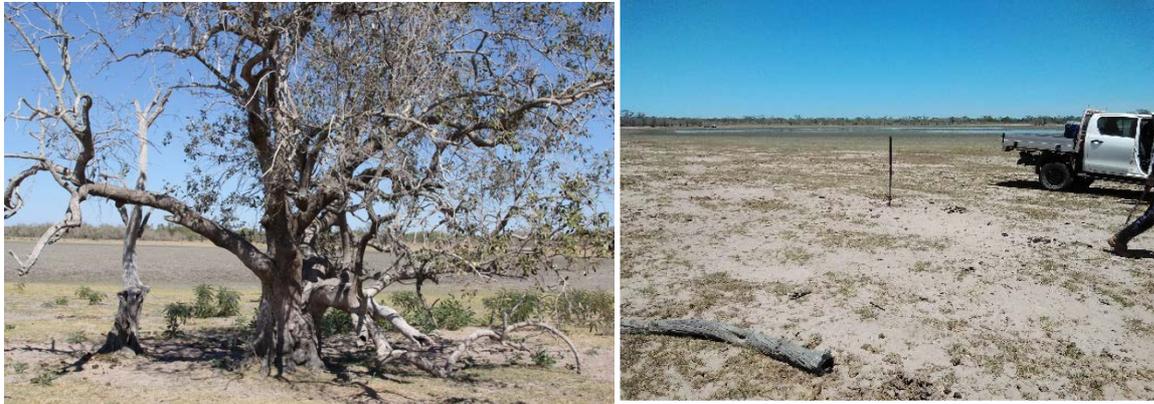
Figure 6-21. Photos demonstrating lardig trees in poor condition and low levels of plant cover within the transects during monitoring in June 2019.

A balance between plant recovery and hunting may need to be addressed in the future if the plant cover around the lake responds to cattle exclusion. CMs noted that if fencing causes plants to grow back hunting may be a little harder, but this could be balanced by the plant growth supporting higher populations of valuable species including *barni* and *barrgara* (goanna and turkey), which would be a benefit to hunters.

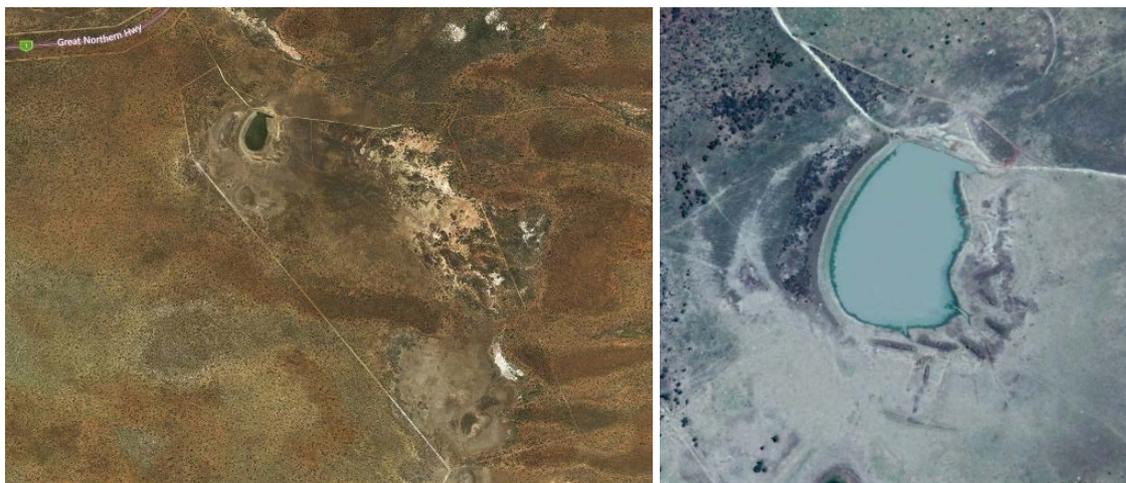
Figure 6-24. Taylors Lagoon showing (a) old fence line covering both Taylors Lagoon main area and depressions to the south-east and (b) formations around the main wetland where excavated soil has been placed in rows.

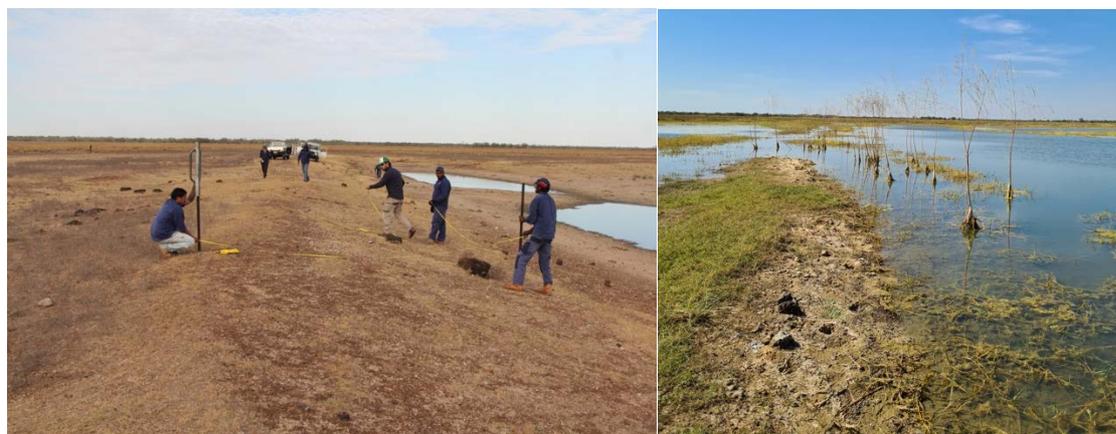
Figure 6-26. Photos demonstrating seasonal change at Taylors Lagoon: (a) the lagoon was dry with very little plant growth in August 2019 and (b) *Sesbania* and groundcover growth in May 2021 following the 2020–21 Man-gala (note cattle trampling still evident).

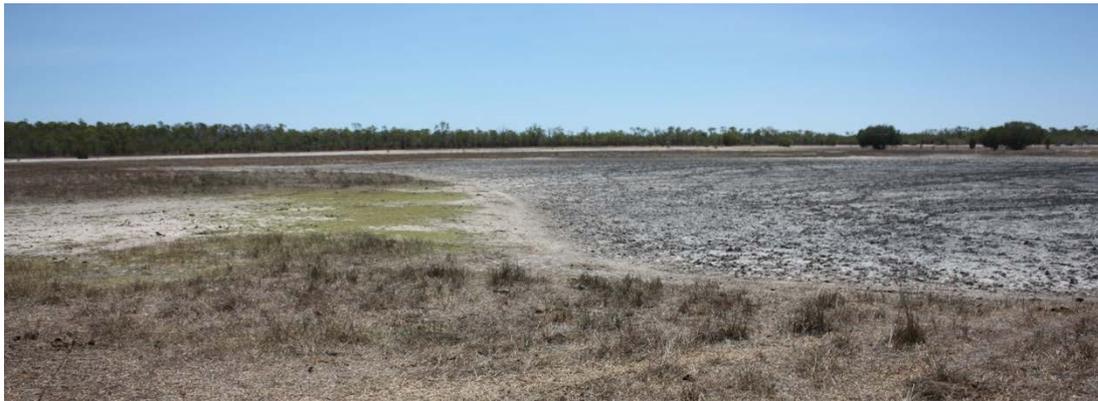
Figure 6-27. Ungani Lakes showing cattle tracks at the edge and across one of the ephemeral lakes.
